**PRITCHARDS POND DAM  
CT 00033**

**NAUGATUCK RIVER BASIN  
WATERBURY, CONNECTICUT**

**PHASE I INSPECTION REPORT  
NATIONAL DAM INSPECTION REPORT**

Re: Pritchards Pond Dam  
Waterbury, Connecticut  
Contract #DACW-33-81-C0017

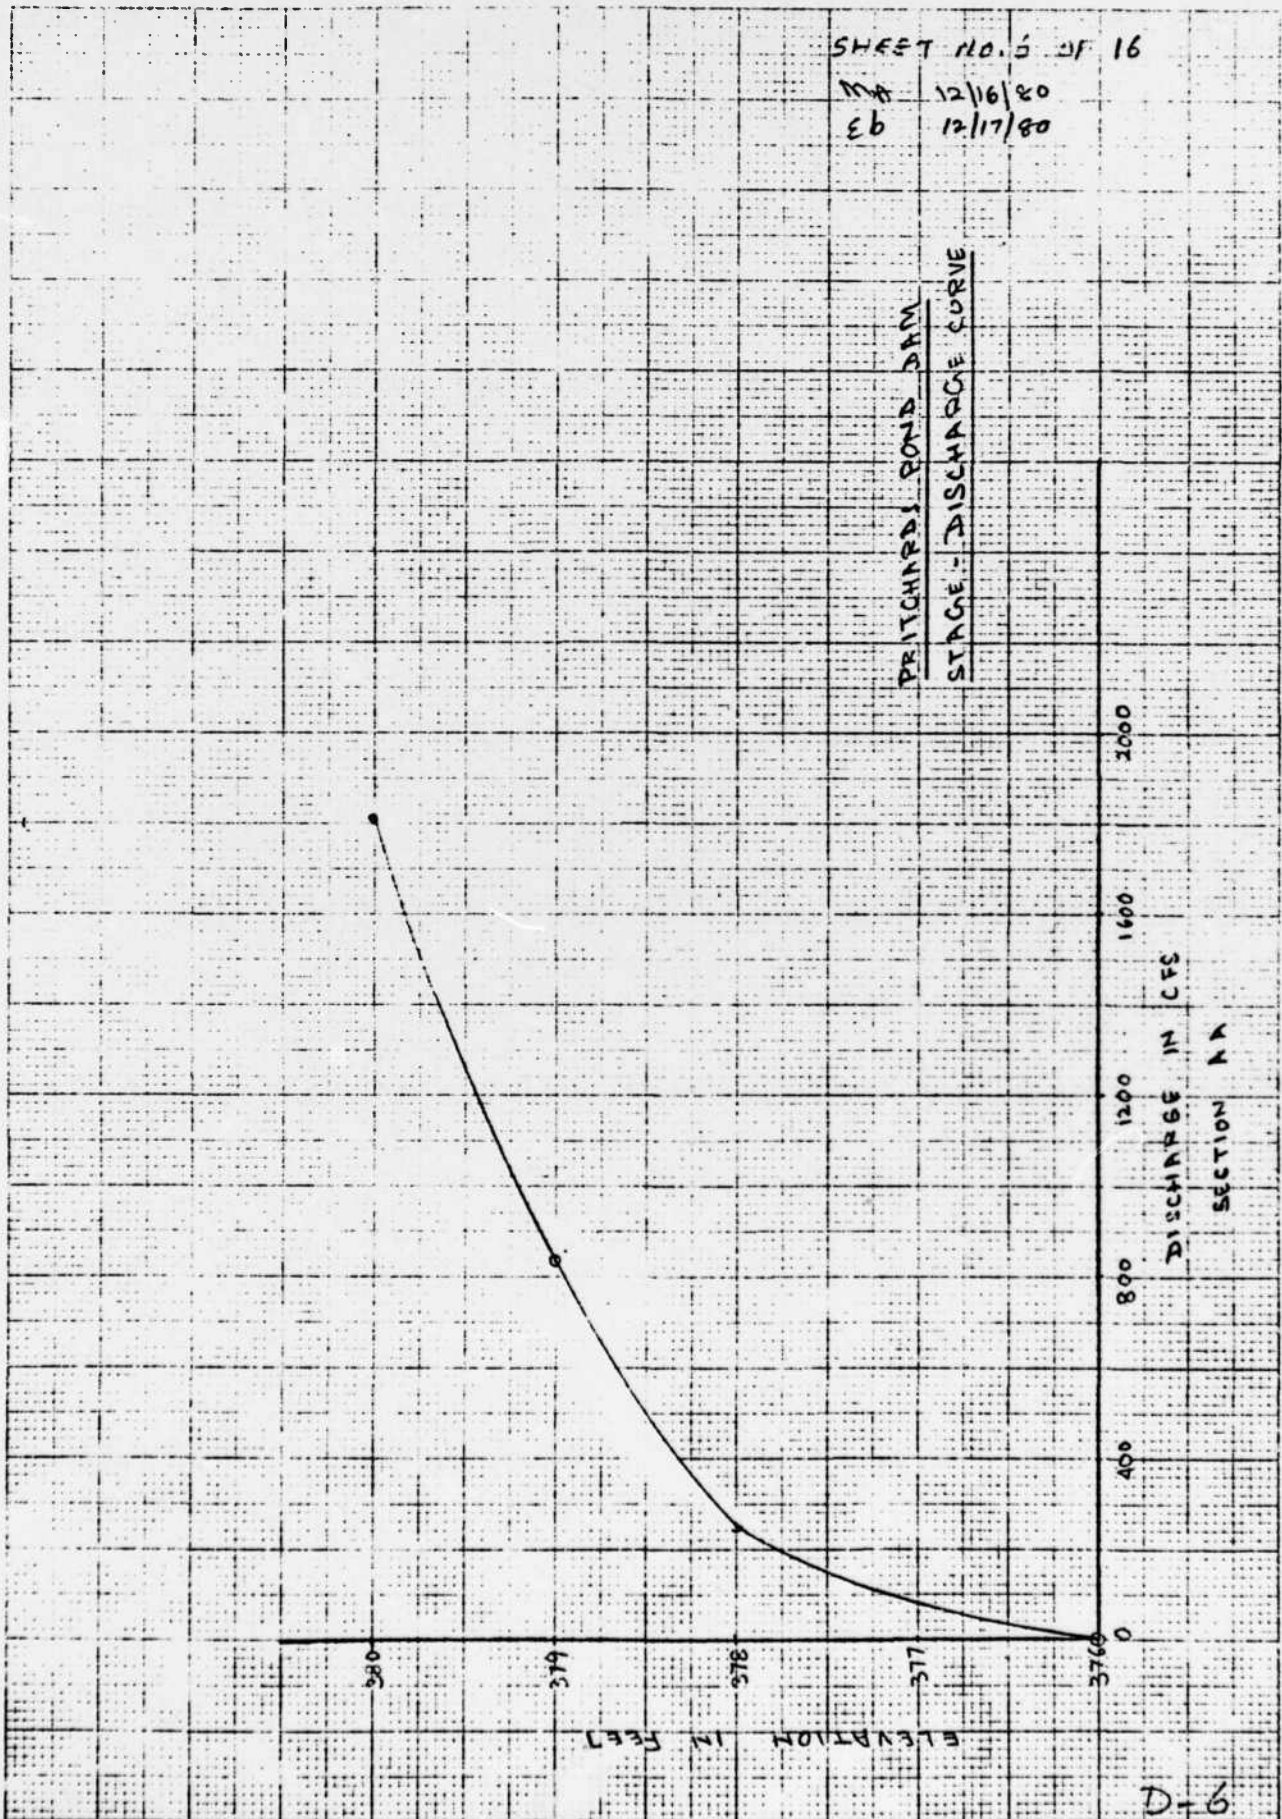
THUS, AT SECTION AA, NO SERIOUS FLOOD HAZARD IS LIKELY TO OCCUR.

IT IS HOWEVER, NOTED THAT THE CULVERT ON SPRING LAKE RD. IS INADEQUATE TO ACCOMMODATE THE ENTIRE PEAK OUTFLOW AT DAM FAILURE.

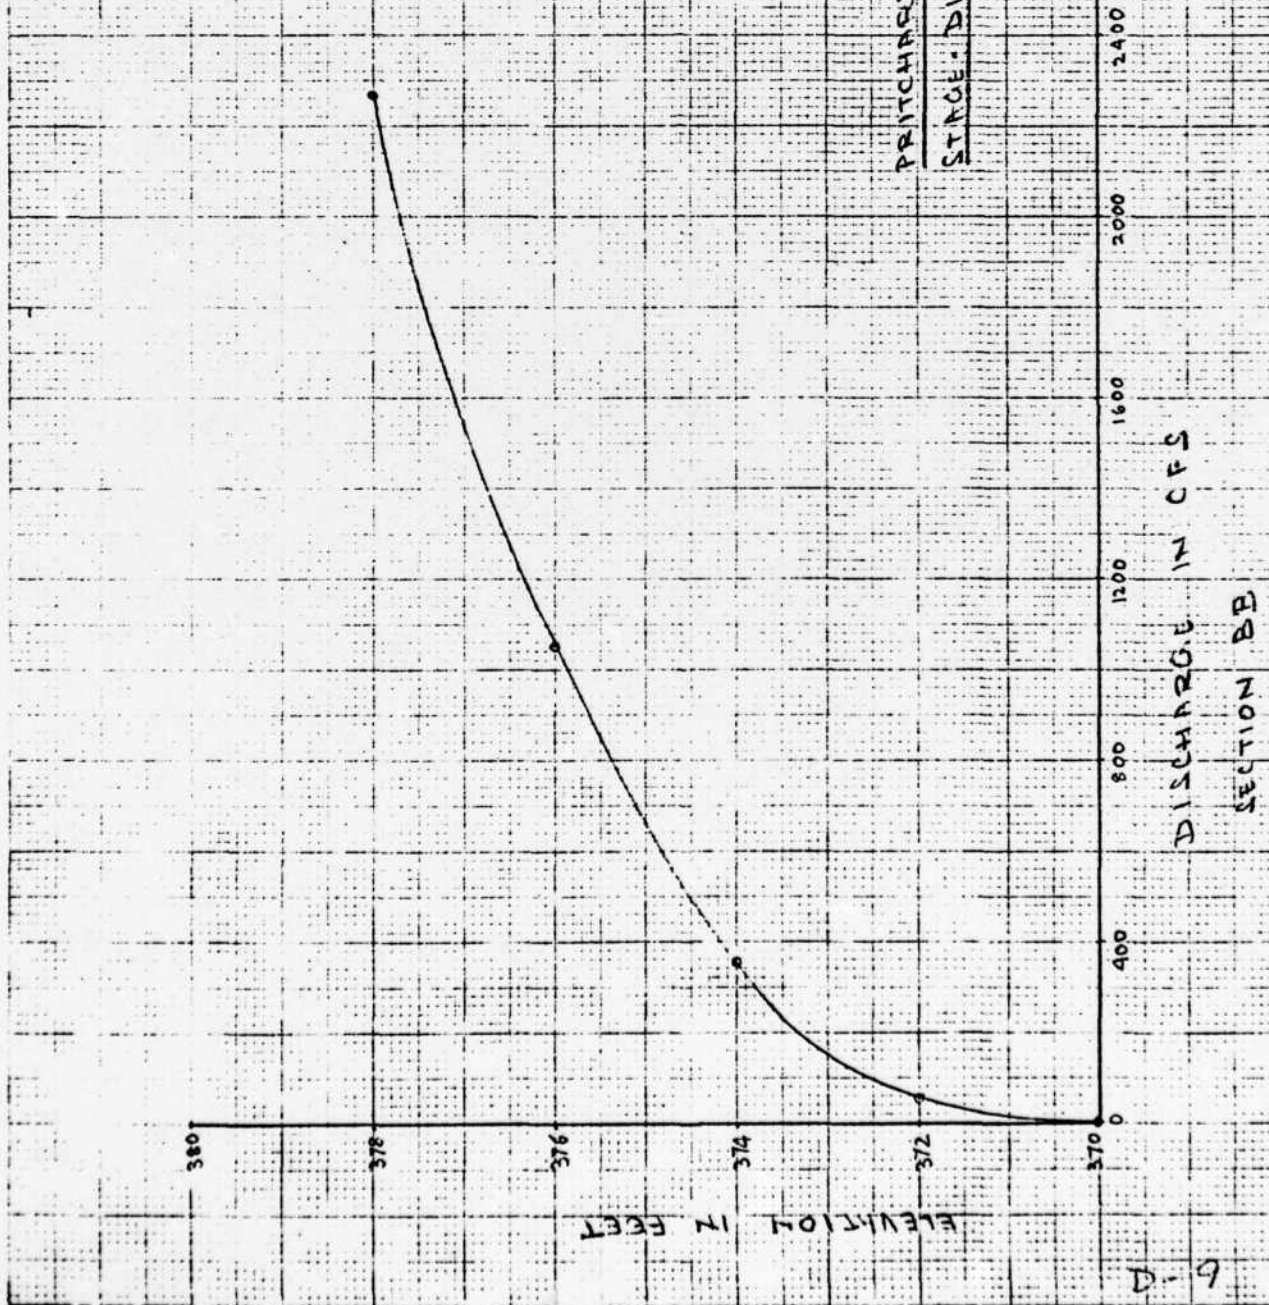
THE TWO HOUSES ADJACENT TO THE SMALL POND LOCATED AT SECTION BB ARE HIGHER THAN THE ESTIMATED FLOOD STAGE; THEREFORE ARE NOT LIKELY TO BE IMPACTED BY DAM FAILURE:

FOR PEAK FAILURE OUTFLOW  $Q_1 = 1148 \text{ CFS}$

NO DAMAGE IS EXPECTED TO OCCUR  
 IN THIS REACH.

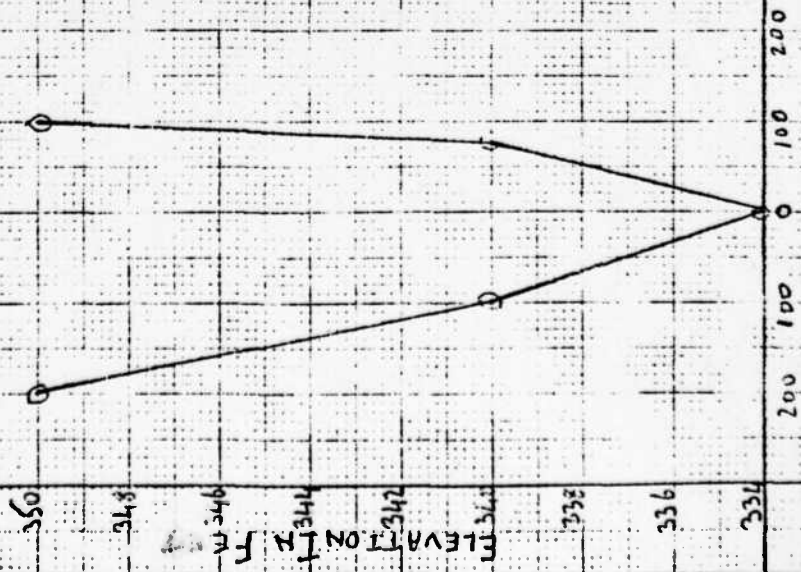
HORIZONTAL DISTANCE IN FEET  
LOOKING DOWNSTREAM  
SECTION CC

FOR PEAK FAILURE OUTFLOW  $Q_1 = 1032 \text{ CFS}$ , THE STAGE  
DISCHARGE CURVE GIVES ELVN = 326.18 AND AREA  
= 270 SQ. FT.
